TECHNICAL REPORT ARLCB-TR-77043

TEMPER. EMBRITTLEMENT IN 4140 SEAMLESS TUBING

Steve Tauscher
Peter Thornton

November 1977

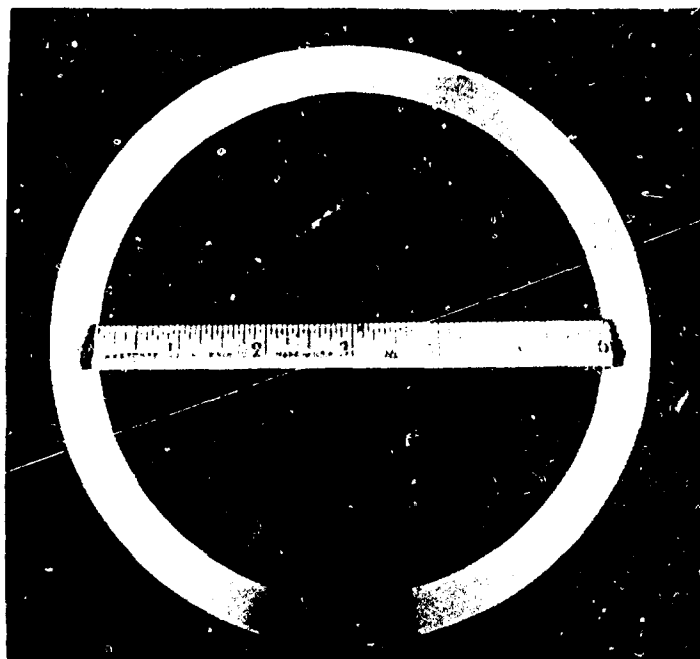
In early November 1976, several 155mm M185 split rings (Fig. 1) fabricated from SAE 4140 steel seamless tubing cracked during various stages of their manufacture. In all reported failures, the rings had been heat treated and "kinked", an operation whereby the component is plastically deformed and acquires a considerable residual tensile stress. This stress is necessary for the subsequent operation of the component.

Preliminary investigations revealed that the rings were of high hardness (R_c 49-51 versus R_c 43-48 specified) and had fractured in a brittle manner. The heat treatment specified a temper of 750°F (399°C) which is within the known temper embrittlement range for this alloy. SEM fractography revealed the primary mode of fracture to be intergranular (Fig. 2). This examination also revealed that the fracture likely initiated at a stringer-type non-metallic inclusion which intersected the metal surface. Accordingly, a metallographic inspection of a mounted specimen taken from the ring showed the microstructure to contain numerous stringers of non-metallic inclusions as well as globules of a second phase material (most likely carbide precipitates) in the grain boundaries. Surprisingly though, these grain boundary precipitates were not observed on the fracture surface during the scanning electron microscopy (SEM) examination.

Figure 1. Overall view of split ring: Segment removed for analysis.

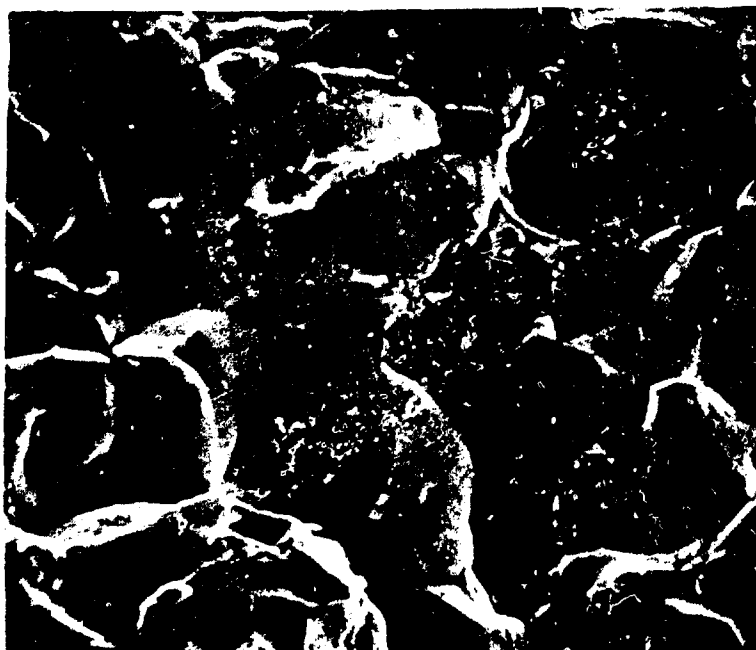
Figure 2. SEM fractograph of cracked split ring showing intergranular mode of fracture.

Nevertheless, temper embrittlement was suspected, as this phenomenon manifests itself as a loss of toughness in a steel and a tendency to fracture along prior austenitic grain boundaries¹. In some cases, this embrittlement is viewed to be a manifestation (the result of a buildup) of impurities (such as Sb, Sn, As, P or Se) along grain boundaries as a result of the rejection of these elements from carbide precipitates in the boundaries². These characteristics of temper embrittlement (which parallel the previously mentioned conditions found in the steel) coupled with the fact that the components were tempered within a known embrittling range for SAE 4140 steel strongly suggested that temper embrittlement was indeed responsible for the failures.

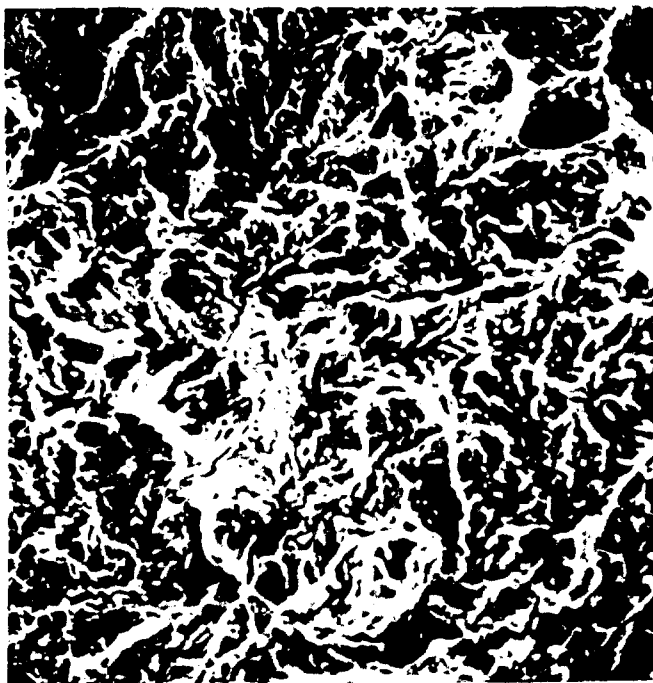
Fractographic examination of broken CVN bars indicates the increasing tendency towards "low energy" intergranular failure as opposed to "low energy" cleavage failure as the tempering temperature is lowered. The 1000°F (538°C) temper displays quasi-cleavage as the principal mode of failure (Figure 6). This mode, however, changes to a mixed mode of intergranular and quasi-cleavage in the 750°F (390°C) temper (Figure 7). The high energy mode of failure for both tempers was ductile fracture by microvoid coalescence (Figures 8-9).

Figure 6. SEM fractograph showing cleavage failure mode - 1000°F temper - 960X.

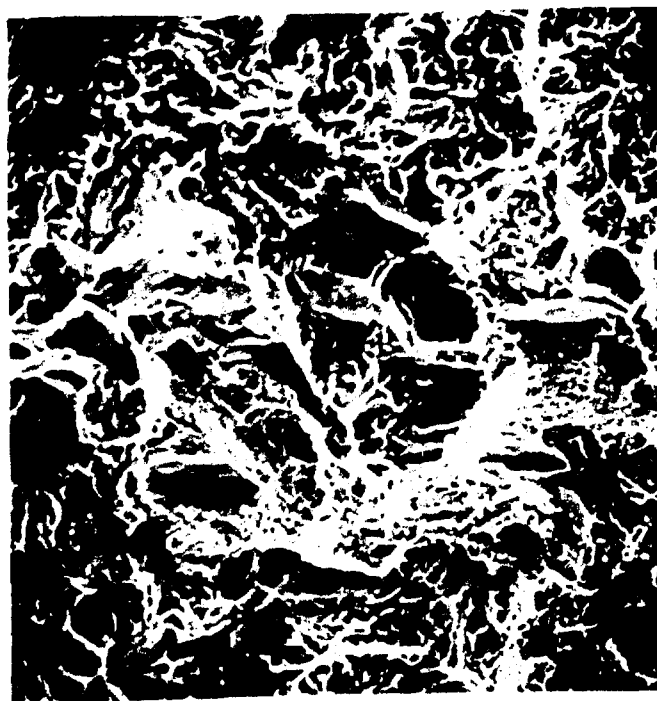
Figure 7. SEM fractograph showing cleavage and intergranular failure modes - 750°F temper - 900X.

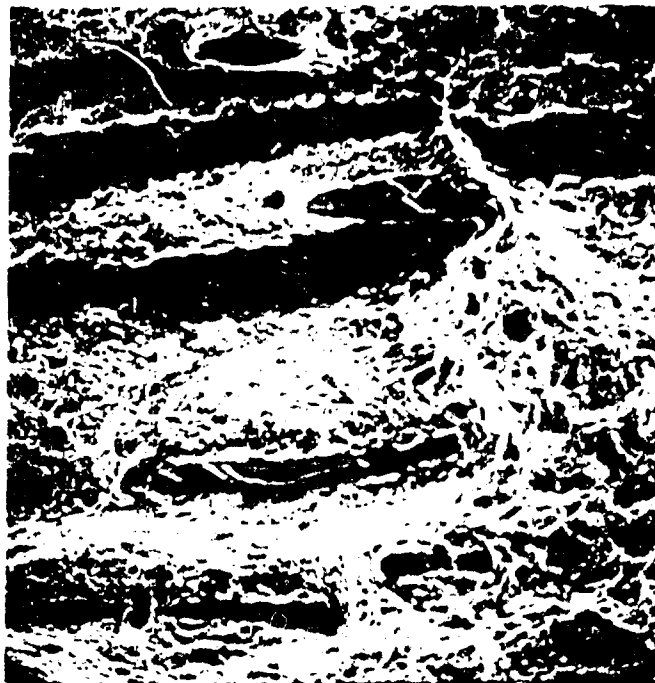
Figure 8. SEM fractograph showing ductile failure
mode - 1000°F temper - 500X.

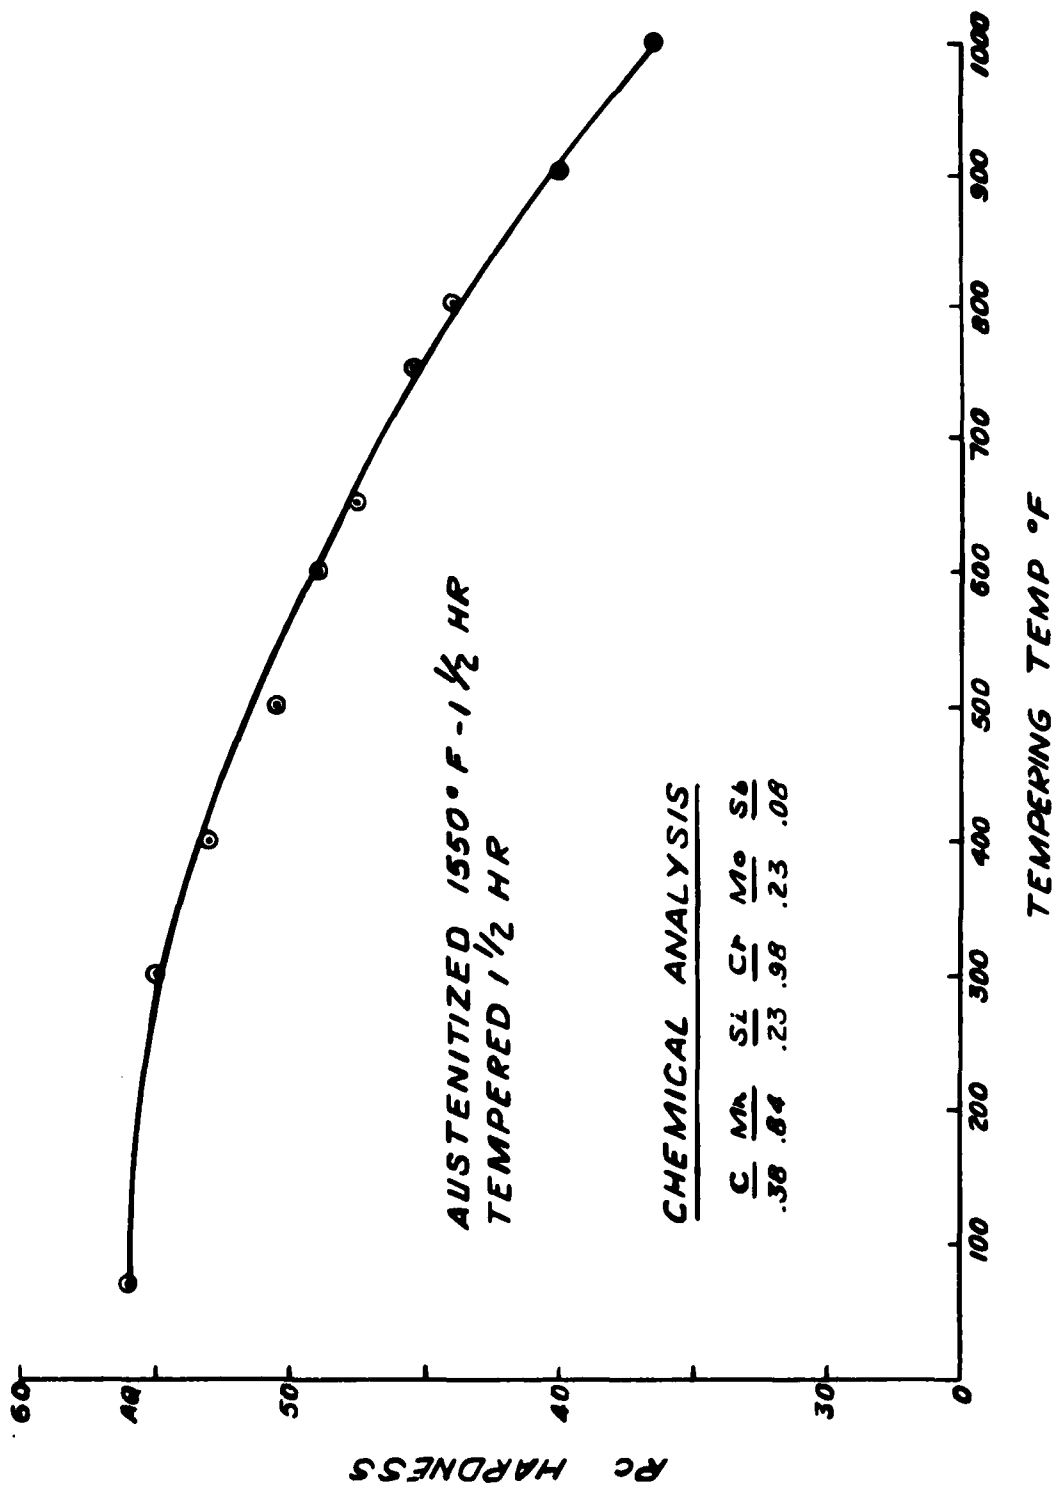
It is important to note that the high hardness of the split rings investigated was obviously not achieved using the reported heat treatment the rings undergo. This was substantiated by conducting a series of heat treatments at lower tempering temperatures. Table 3 reveals the actual tempering temperature required to obtain Rc 50 hardness (in this steel) to be approximately 500°F (200°C) as opposed to the 750°F (399°C) temper reportedly given the split rings. The tempering response for 4140 steel is plotted in Figure 10.

Figure 10. Tempering response of 4140 steel.
